Construction Report

St. Vrain Mill Foundation Stabilization

Project No. 140571

March 2018

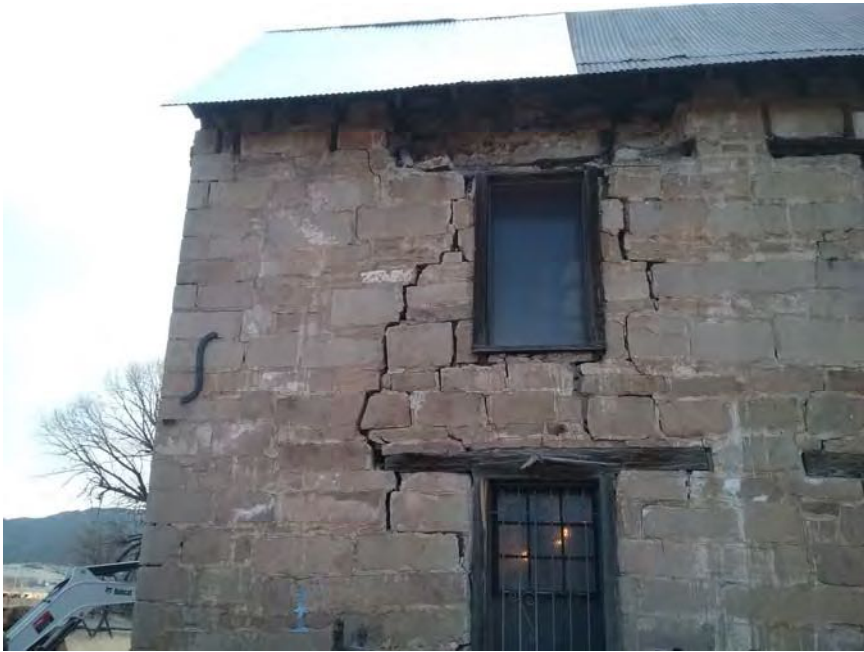
PHOTOGRAPH 3: West wall cracking

As indicated in the *Stabilization and Structural Assessment Report*, a large pre-existing crack is present on the east and west walls of the structure. The crack on the east wall is most significant and measures larger than 9 inches wide in some locations between the ground surface and roof of the structure. Prior to construction, the Owner installed a measurement device on the east wall crack to monitor the width of the crack over time. During the foundation stabilization construction, it was observed that the crack widened by approximately $\frac{1}{4}$ to $\frac{1}{2}$ inch on the second story of the building. This movement is most likely due to the addition of pressures below the building foundation. While this does not raise immediate concerns for the structural integrity of the building, continuous monitoring of the crack is advised. It is believed that the foundation has now been stabilized as a result of construction and minimal further movement is anticipated.

It is recommended that movement at the cracks of the building continue to be monitored, recorded and documented. Monitoring should continue regularly until minimal or no movement is observed. Once any movement has decreased, it is recommended that wall repair occur as described in the September 2015 report by Engineering Analytics.

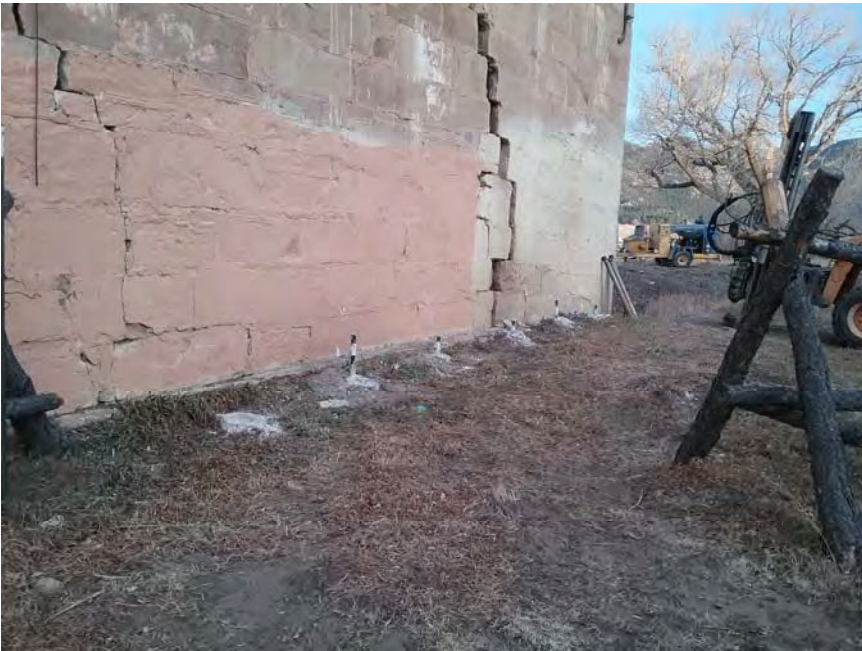
PHOTOGRAPH 5: East wall permeation grout locations

Hayward Baker began drilling holes to a depth of approximately 6 feet below the ground surface (4 feet below existing wall foundation) and injecting these holes with permeation (chemical) grout on January 10, 2018. Locations of permeation grout are indicated on the drawings with solid circles and are spaced at 4 feet on center. Permeation grouting was completed on January 12, 2018.

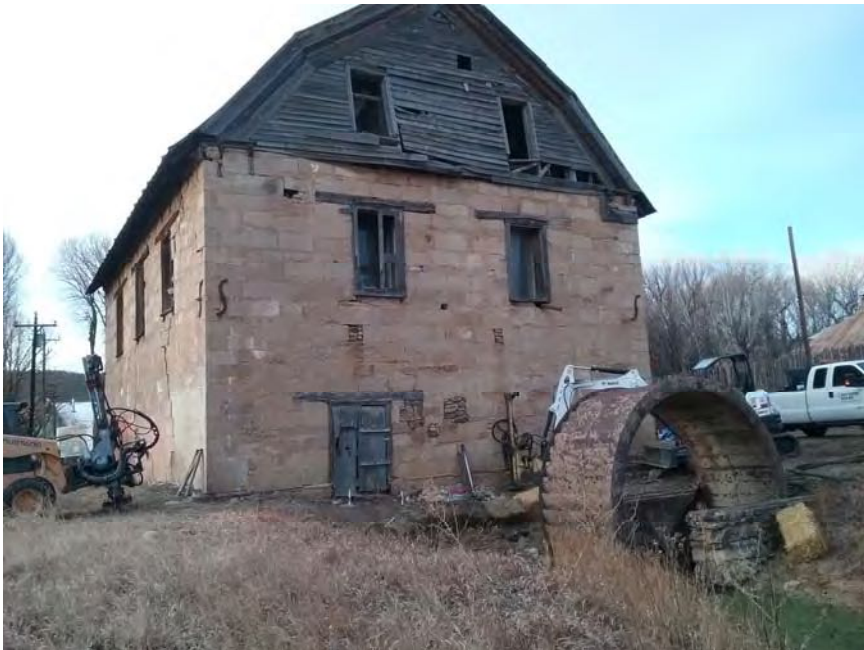
PHOTOGRAPH 11: Water wheel N. of building

While drilling occurred at the northwest corner of the building and on the outside of the building, activity was observed at the water wheel directly north of the building. While no obvious structural movement was observed, air bubbles and water movement was observed near the water wheel. This movement is assumed to be a result of the drilling occurring within or below the existing water table, therefore fluctuating the standing water near the water wheel. This activity is not anticipated to be a structural concern to the building or the water wheel structure.

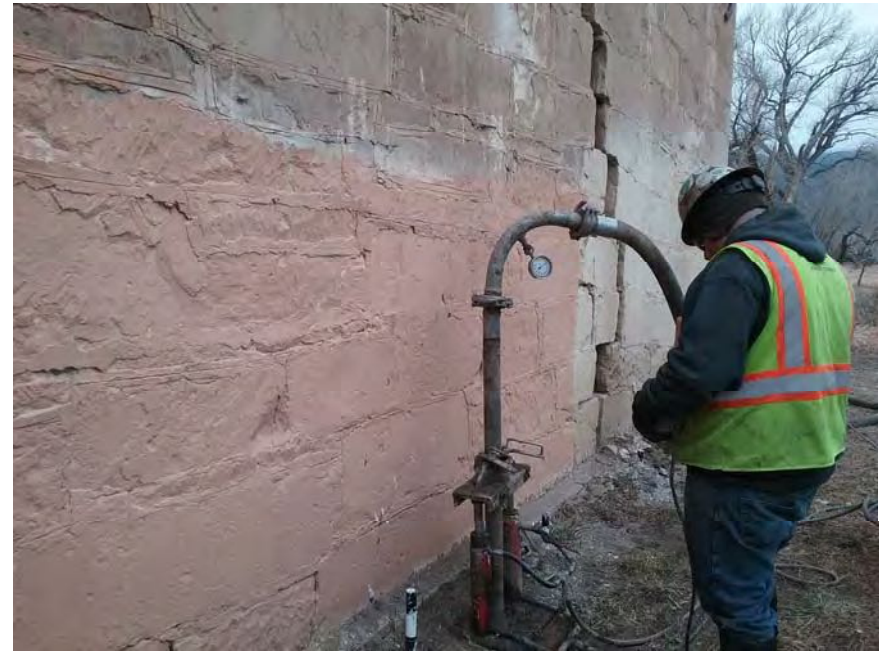
PHOTOGRAPH 24: Pumping grout outside E. wall

After permeation grouting was completed, Hayward Baker began drilling through the permeation layer at the locations for compaction grouting. Compaction grouting locations are indicated on the drawings with solid diamonds and are spaced approximately 8 feet on center. The compaction grout holes were first drilled to a depth of 4 feet below the permeation layer, and were injected with grout in a top-down grouting method from approximately 4 feet to 8 feet below the foundation (directly below the permeation layer). At least 12 hours after the top-down grouting was completed, the holes were drilled again but to a depth of 20 feet below the permeation layer. From the depth of 20 feet below the permeation layer, compaction grout was injected in a bottom-up fashion to the previously placed compaction grout at 4 feet below the permeation layer and through the hole drilled in the higher layers of grout. Compaction grout was placed in 1-foot lifts, and advancement to the next lift was dictated by achieving 300 psi, injecting 3 cubic feet of grout material, or having grout material protrude from the hole at the ground surface at the current lift. Typically, 2 or 3 cubic yards of grout were injected into each lift, and the pressure at each lift ranged from 150 to 400 psi.
